# DOWNTOWN PARKING REVITALIZED

## FIRST & JASPER PARKING DECK FLOOR SLAB REPLACEMENT

BY DARYL PREFONTAINE

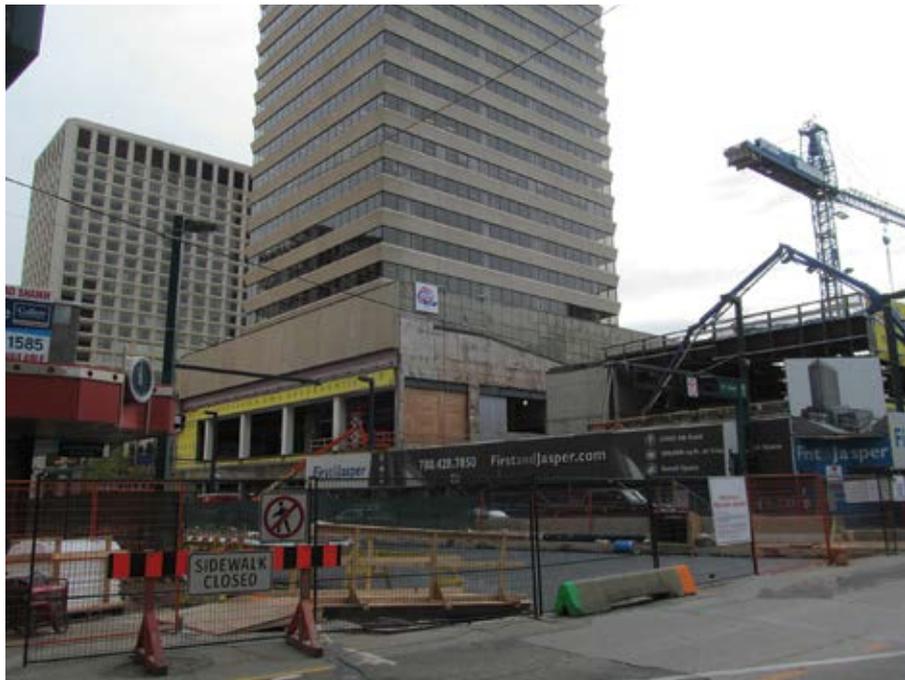
Fig. 1: Overall view of project site during construction

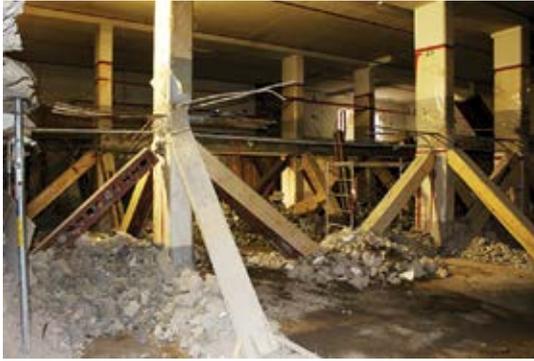
*Fig. 2: Steel bracing members installed prior to concrete removal at core walls, columns, and perimeter walls. Plywood sheathing was applied to protect steel members from damage during the construction demolition process*

The significant complexity and challenges of the First & Jasper Parking Deck floor slab replacement project included maintaining the load-carrying capacity of the office tower's columns, core, and perimeter basement walls during the demolition and reconstruction work (Fig. 2). Removal of the underground supported parking level had the potential to reduce lateral support for the vertical structural members, thus creating a risk of localized or widespread structural failure or collapse. Lateral bracing assemblies were designed and incorporated into the repair methodology and the concrete demolition work and reconstruction of the parking deck floor slab was carefully sequenced and phased to ensure that structural failure or weakening of the office tower would not occur during the work (Fig. 3 through 5).

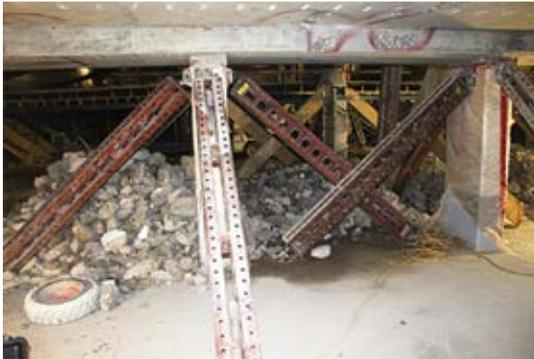
*Fig. 3: Typical column bracing along demolition phasing boundary. Demolition debris was stockpiled on slab-on-ground during some phases of work*

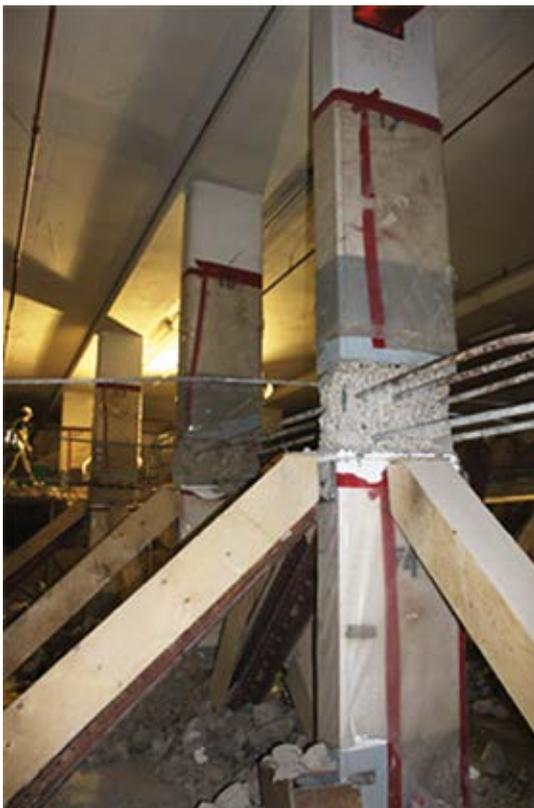
*Fig. 4: Interior concrete columns braced to maintain load-carrying capacity*

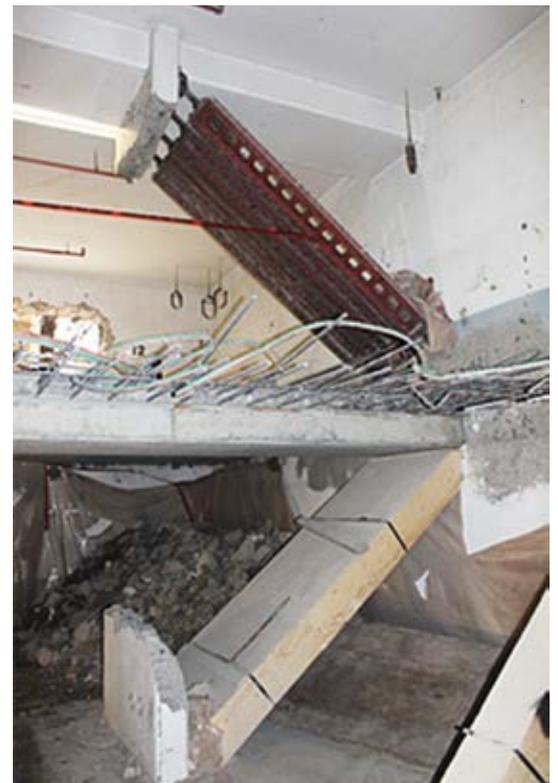
*Fig. 5: Significant bracing was required at the north interior wall to ensure the stability of an adjacent LRT Pedway tunnel cantilevered from the building structure*

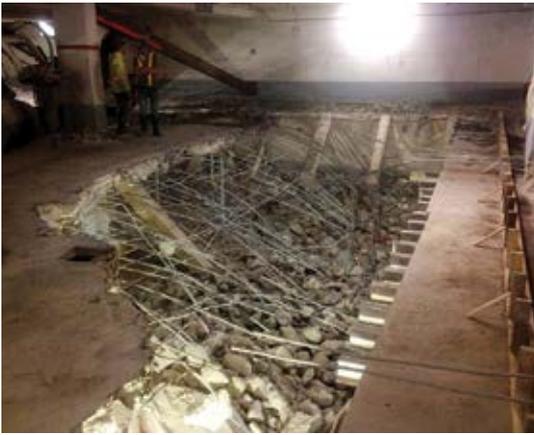
Fig. 6: Slab demolition in progress

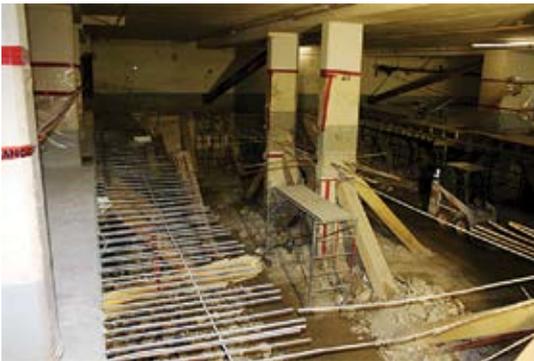
Fig. 7: Slab removal and replacement operations were carefully sequenced over several phases to maintain lateral support for the building walls and columns, while minimizing bracing and shoring requirements

The structural risks were managed by carefully phasing and sequencing the demolition and reconstruction work to maximize the ability of the remaining portions of the existing concrete structure to provide continued lateral support for the office tower's vertical structural elements, which extended through the underground parking levels (Fig. 6 and 7). In addition, the strength of the new concrete elements were tested and monitored to ensure they had achieved sufficient strength and capacity to provide support for these critical concrete elements

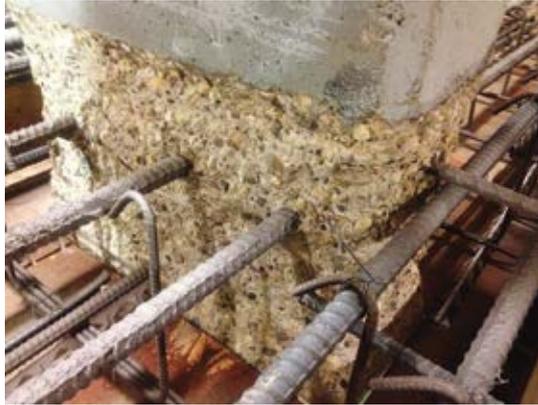
Fig. 8: Existing slab and slab-band reinforcing steel were maintained, abrasive-blast cleaned, and reincorporated into the new work at the perimeter walls, core walls, and interior columns

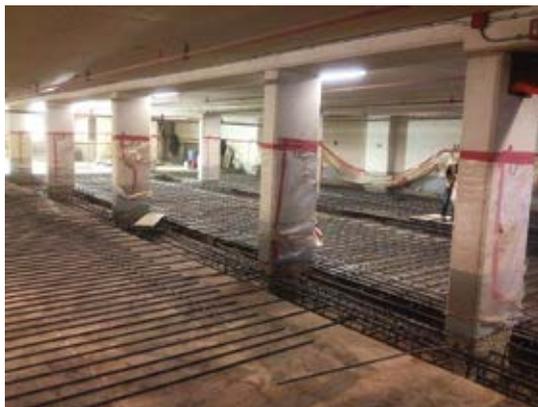
Fig. 9: Forming and placement of new reinforced parking deck floor slab prior to concrete placement

- The incorporation of significant levels of fly ash (25% replacement of cement content) into the ready mixed concrete materials.
- Existing reinforcing steel was maintained, cleaned, and reincorporated into the new concrete parking level structure at perimeter slab edges, core walls, and where extending through interior column sections (Fig. 8).
- Additional new reinforcing was provided to supplement existing corroded bars, and as necessary to meet current code requirements for flexural, shear, progressive collapse, and integrity reinforcement (Fig. 9).

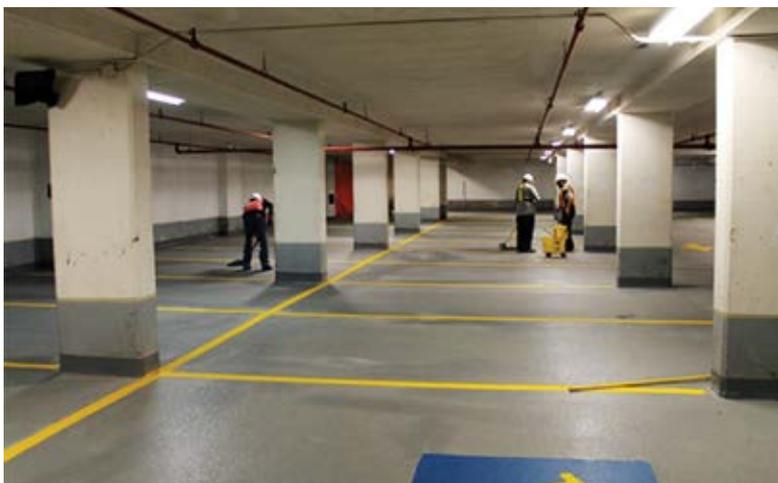
Fig. 10: Highly durable protective coating and sealant materials were used on the new parking deck floor slab surface

- The selection of a highly durable protective coating and sealant materials (Fig. 10).  
In addition to the structural considerations, other environmental sustainability initiatives included the following:
- Original lighting fixtures were removed and replaced with higher-efficiency fixtures. Lighting levels were improved for vehicle and pedestrian
