Performance Pandemonium: Designing & Modifying the ETFE Skylight System for the Calgary Zoo's Panda Passage Exhibit

By Jelena Bojanic, B.Sc., EIT, Project Engineer, Read Jones Christoffersen Ltd.

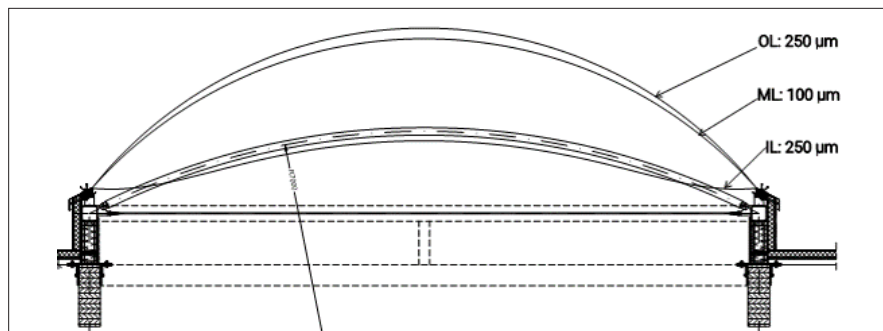
Figure 1. A manufacturer’s drawing showing the thickness of the layers in the ETFE skylight.¹

Given that Calgary, Alberta experiences severe hailstorms during spring and summer months, with hail pieces ranging from 25 to 50 millimetres in size, this was an imperative design load to consider. The solution was incorporating a three-layer system with a slightly under-inflated outer cushion. The inner and outer layers (IL and OL) are each 250 micrometres thick, while the middle layer (ML) is 100 micrometres thick, as shown in Figure 1 (on page 15).

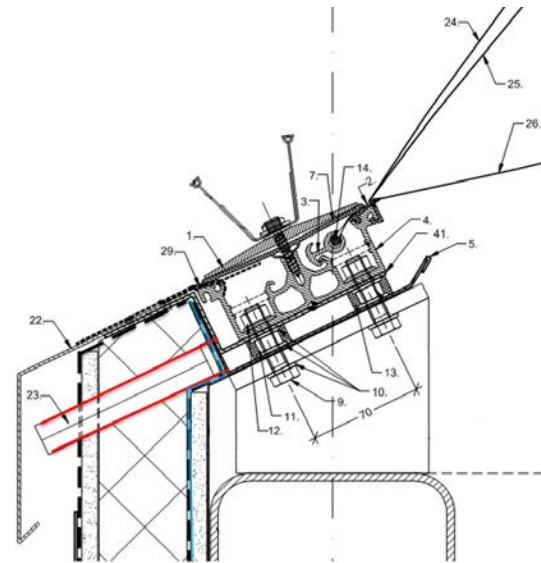
Figure 2. A manufacturer's drawing showing the external drainage (red lines) through the air barrier (blue line).¹

the aluminum profile to the exterior sill (see Figure 2, part 41), creating thermal bridging within the assembly. Calgary experiences significant temperature fluctuations and extreme cold weather conditions, with a winter design temperature of -32°C .⁴ Openings to the exterior would introduce cold air into the system, resulting in higher levels of condensation and freezing of any moisture in the system. Ice build-up inside the system could block the intended drainage path and damage connections along the gutter.

Typical metal skylights glazed with sealed units incorporate pressure equalization and internal drainage without impacting the air barrier or resulting in thermal bridging. RJC suggested these items be revised, as they were not acceptable per industry standards. The proposed spacing between drainpipes was likely inadequate for water to access and expel out of the system and should be revised. The sill should be water- and airtight, with no unsealed openings through the air barrier. RJC suggested providing internal drainage if draining to the exterior was not a possibility without affecting the air barrier. The metal sheet (see Figure 2, part 41) was to be modified to eliminate the thermal bridge through the skylight sill.

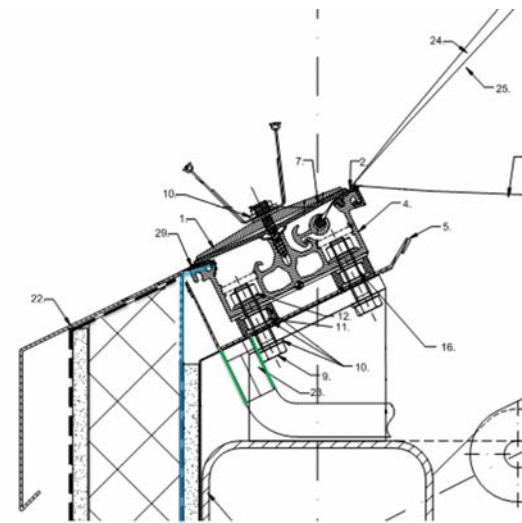
Figure 3. A manufacturer's drawing showing the revised ETFE system with internal drainage (green lines) and the air barrier detail (blue line).¹

The manufacturer revised its design following most of RJC's recommendations. Internal drainage was provided through the condensation gutter and directed to the interior panda space. The layout of the drainpipes was not changed during design revisions. Thermal bridging was mitigated by removing the metal sheet section intended to provide support for the roof membrane tie-in. The final design included tying the air barrier into the aluminum profile, creating a continuous air barrier plane. Figure 3 (on this page) shows the revised section of the system.

perfectly level, and the aluminum profile did not incorporate adjustability (e.g., levelling nuts or incremental shims). The suggested improvement was for the contractor to adjust the positioning of the aluminum frame by using adjustable leveling bolts / nuts (see parts 9, 10, and 12 in Figures 2 and 3).
