CONCRETE REPAIR BULLETIN

# Repair and Protection of a 1950s-era Wastewater Digester Tank Structure: Gold Bar Digester No. 3

EDMONTON, ALBERTA, CANADA

SUBMITTED BY RJC ENGINEERS

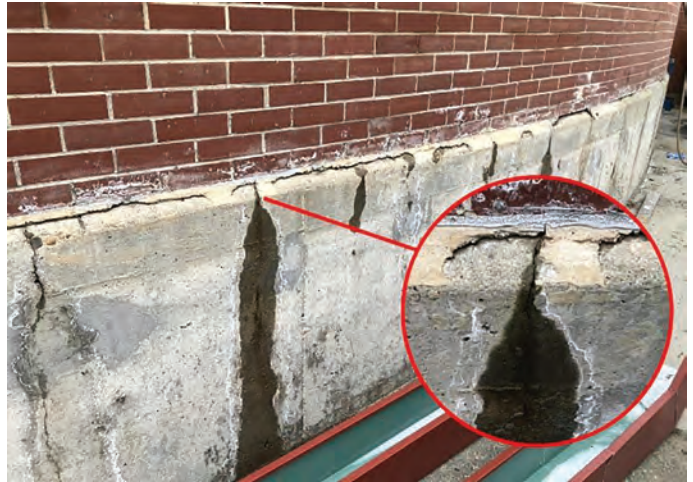
Fig. 1: Original construction of bridge and ramp in 1972

Unexpectedly, the digester did not meet this water tightness criteria (Fig. 1). To ensure that the digester met all regulatory and American Concrete Institute (ACI) requirements, the WWTP management immediately implemented a plan to investigate, design, and undertake a suitable concrete and leakage repair program that would serve the facility into the future.

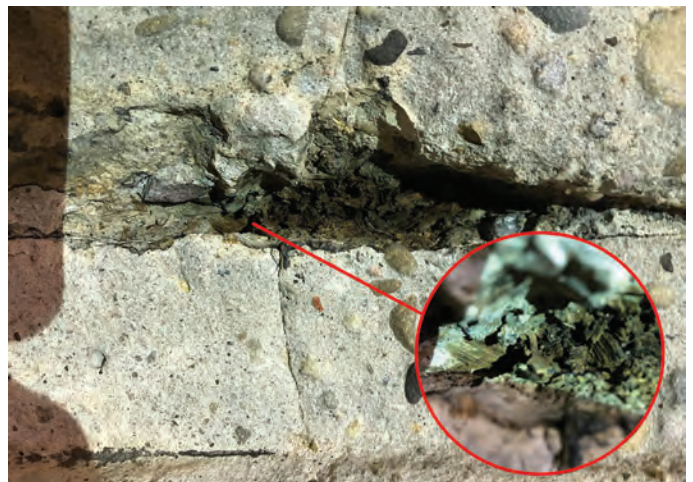
To establish the potential sources of water leakage and the extent of any associated concrete repair required prior to waterproofing, an inspection of the digester's interior surfaces uncovered numerous concrete issues including cracking, cold joints, loose form-tie hole plugs, large areas of poorly consolidated and non-encapsulated aggregate (honeycombing), and void-ridden pour joints with debris embedded at the interface (Fig. 2). None of these conditions were determined to be the sole source of leakage, but all were considered during the design of the new coating.

Fig. 2: Wood debris embedded at pour joint interface

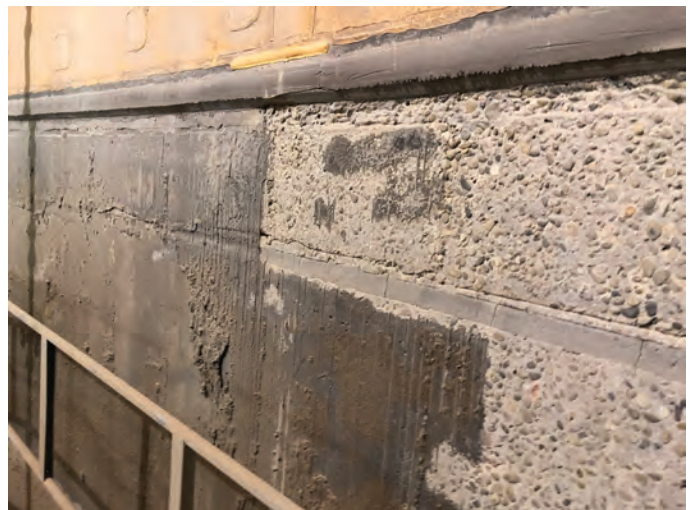
Additionally, based upon the interior inspection and assessment, it was considered that the pre-existing coal tar coating (Fig. 3) was likely providing some level of waterproofing and concrete protection; however, the hydrostatic water tightness testing demonstrated that the coal tar assembly was no longer providing full waterproofing or containment, which was likely the consequence of its extended service life. The observed conditions substantiated the baseline water tightness testing results and aided in defining the potential sources of leakage and repair objectives.

Fig. 3: Partially removed pre-existing coal tar coating

Surface preparation was performed by heavy abrasive blasting to fully remove the existing coal tar coating. This surface preparation method resulted in a rough substrate with a Concrete Surface Profile (CSP) greater than 5 for the 23,600 sf (2,200 sm) of coating application area. Concrete surface pH testing was performed to confirm that the concrete substrates had been adequately cleaned of bond-inhibiting contaminants before proceeding with concrete repair and resurfacing (Fig. 5).

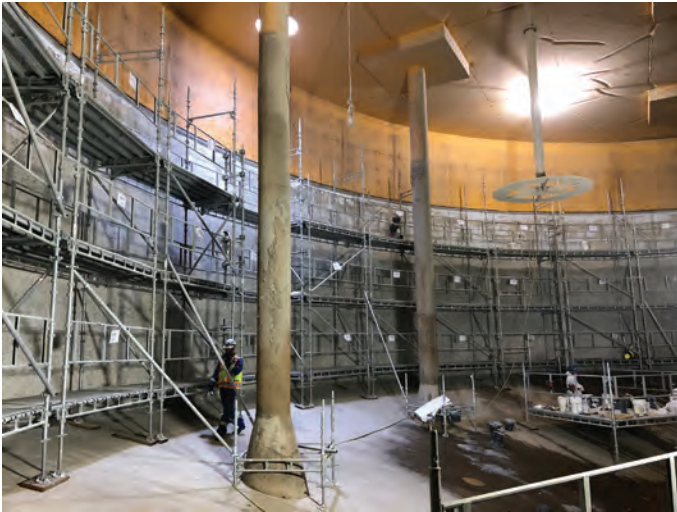
Fig. 4: Access scaffolding set up inside the digester

The structural repair and protection program was implemented in two phases. During the first phase, scaffolding was constructed inside the digester for the cleaning, concrete repair, substrate preparation, and coating application on the lower 21 ft (6.3 m) of interior vertical wall surfaces, up to the underside of the recently installed HDPE liner (Fig. 4).

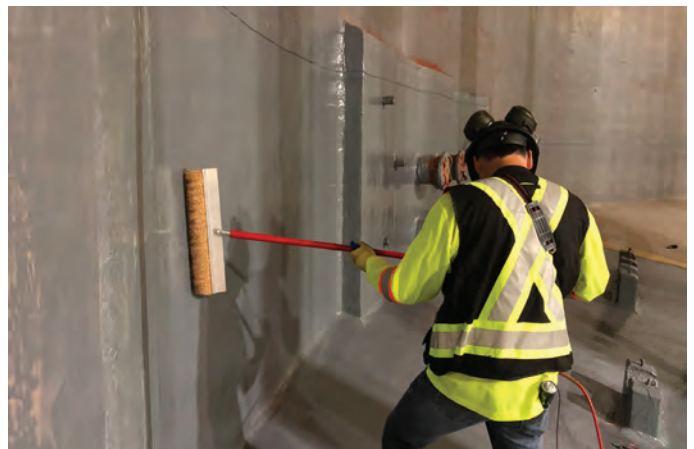
Fig. 7: Holiday/spark testing

In addition to the contractor’s Quality Control and the on-site technical review and support from the material suppliers, Quality Assurance (QA) testing included thickness, adhesion strength pull-off testing, and holiday/spark testing (Fig. 6 and 7).

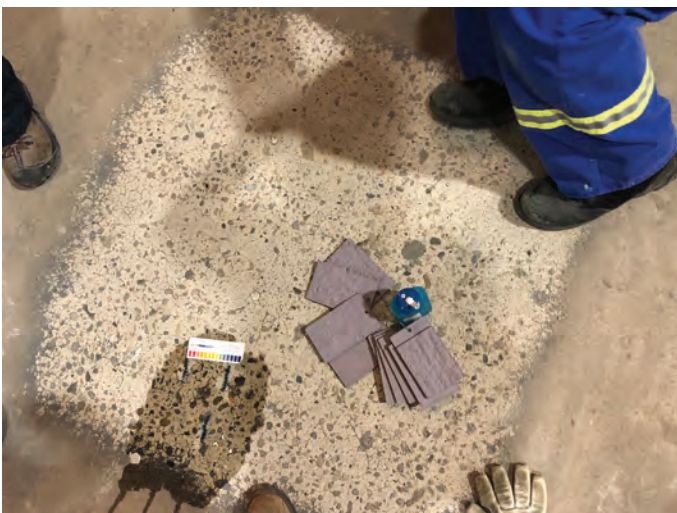
Fig. 5: Determining substrate concrete surface profile (CSP) and pH testing

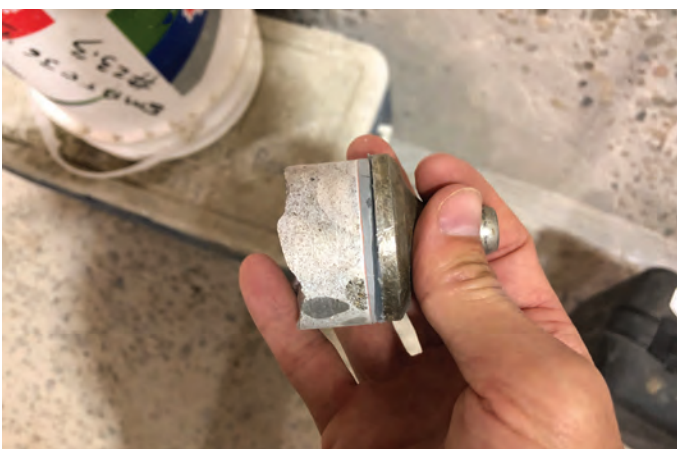
Fig. 6: Failure in original substrate during adhesion strength pull-off testing
