Allan Gardens' crown jewel shines once more after careful restoration

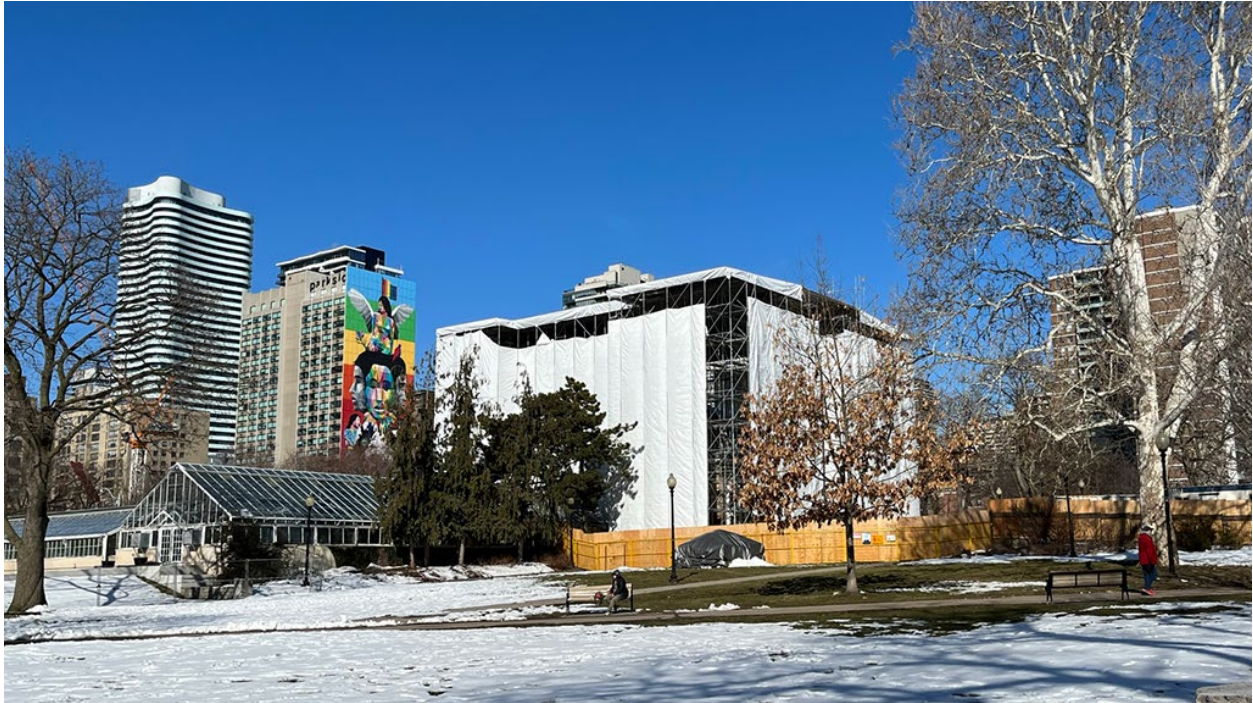
ZIELDER — A view to the north of the exterior scaffolding/enclosure under construction. Tarp “sails” were in the process of being installed to complete the enclosure.

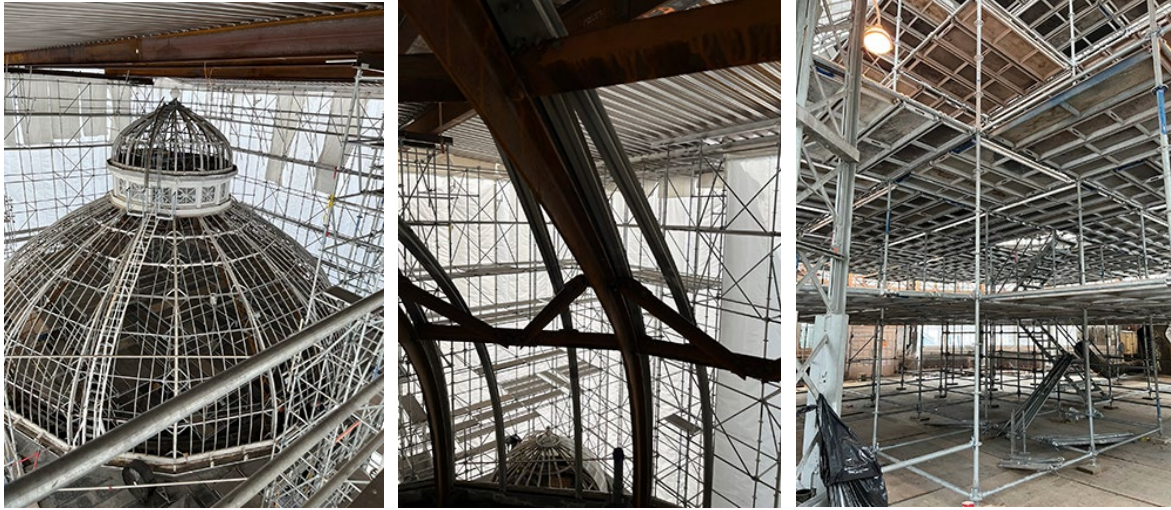
ZIELDER – A view from the upper scaffolding looking down towards the Palm House. Glazing has already been removed in the photo. Interior scaffolding is visible through the dome.

After glazing subcontractor Universal Aluminum took out the original glazing, the lead paint on the dome’s 16 sloping steel trusses was removed and the trusses repainted. Next in this sequence was the installation of the new glazing which consists of 950 laminated glass panels. The vertical aluminum mullions were kept in place throughout construction, says Firestone.

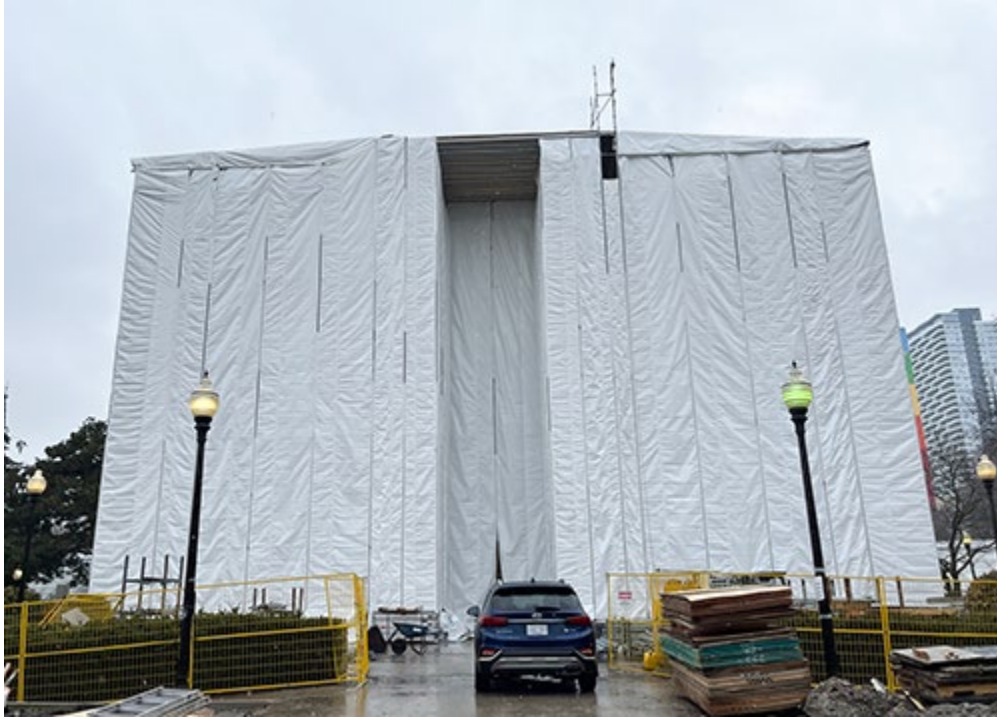
ZIELDER — A view facing west towards the main entrance showing the exterior scaffolding and “sail” enclosure around the Palm House.
