Crews push through scary conditions to create a new atrium roof at the Snow Ghost Inn

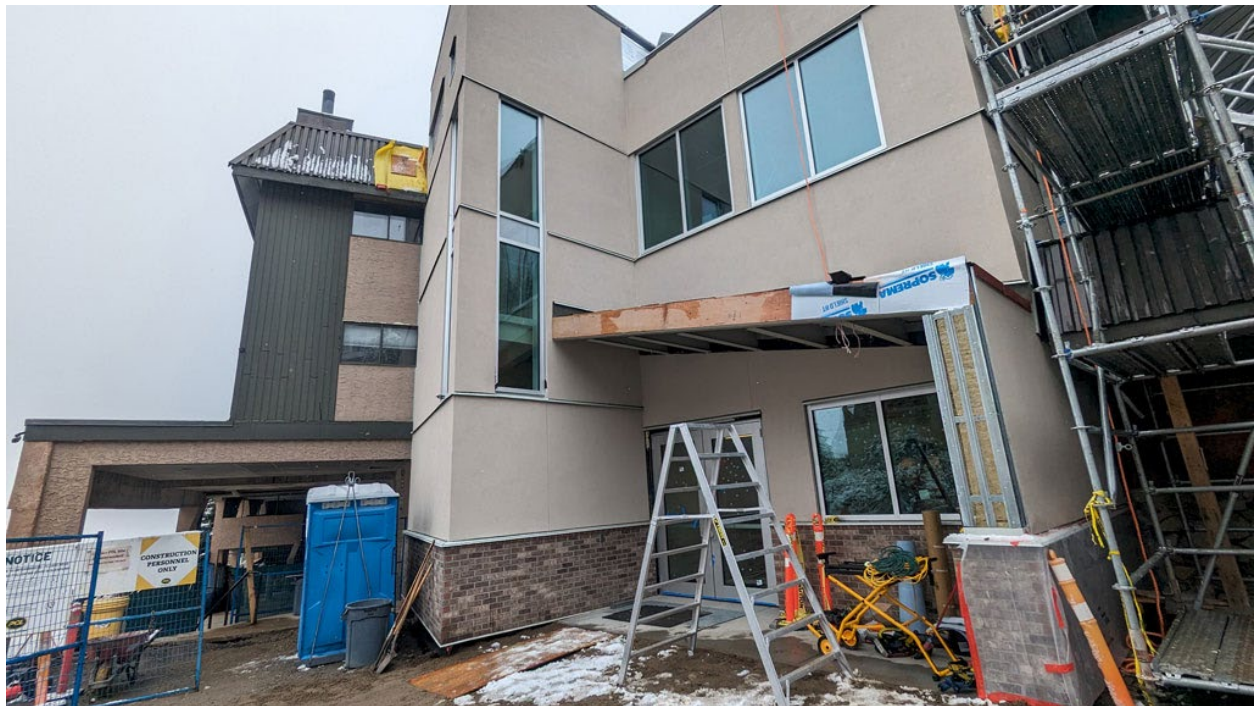
RJC ENGINEERS — Shown is a nearly completed view of the new entrance to the atrium.

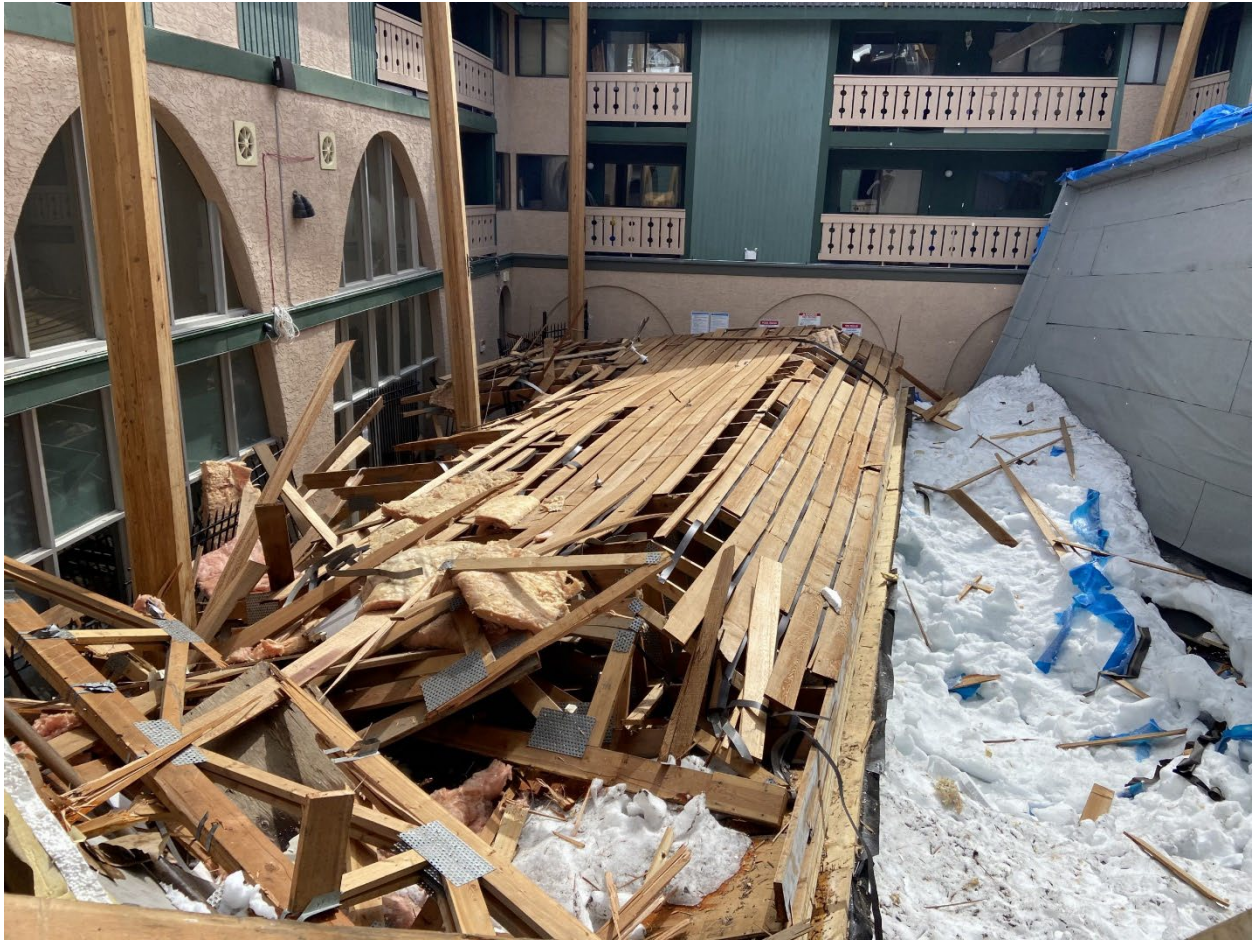
RJC ENGINEERS — Shown is the pre-existing atrium roof timber framing post-collapse.

From a structural design perspective, one of the greatest challenges was redesigning a new roof without making massive changes to the building envelope. The original support system consisted of engineered wood roof trusses on glulam beams which, in turn, were supported by circular timber columns on shallow cast-in-place concrete pedestals and footings, says Perrin.

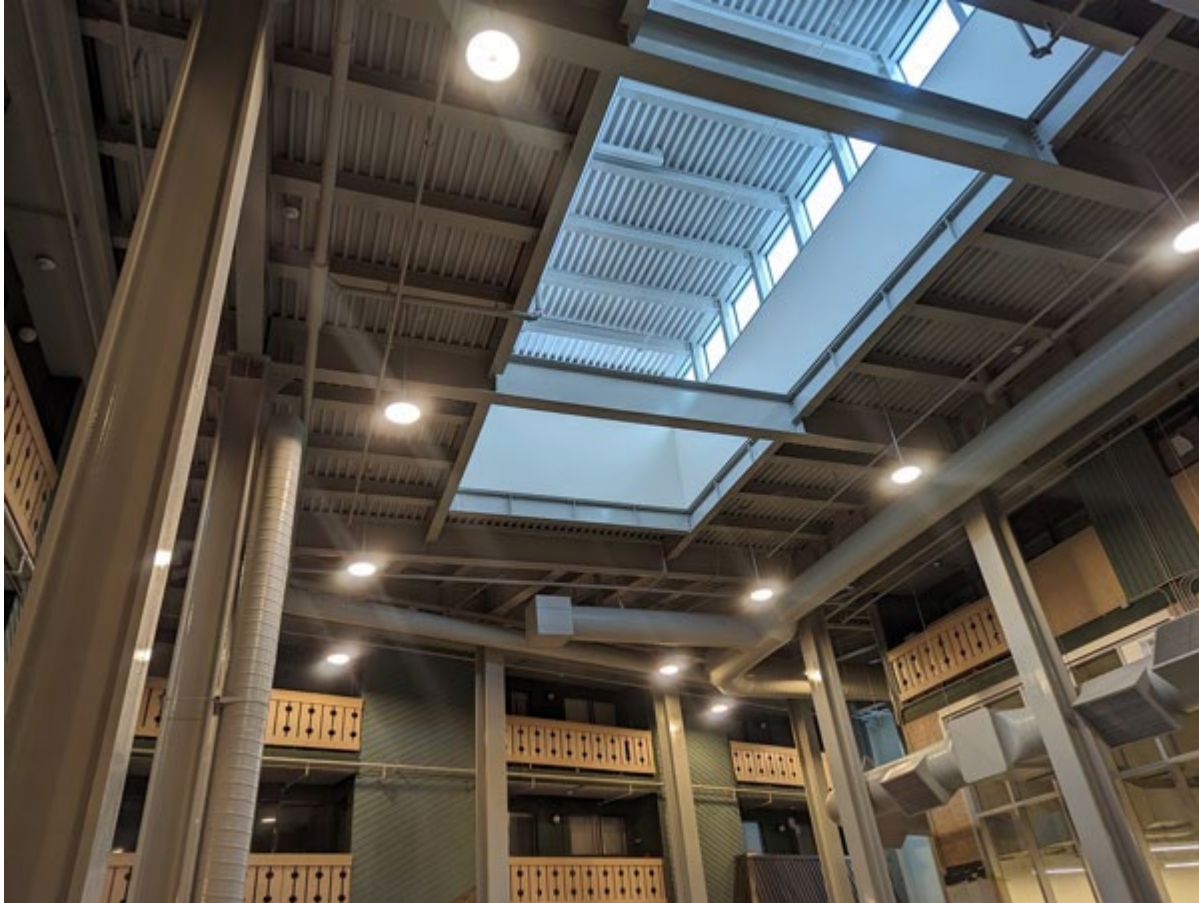
RJC ENGINEERS — View of the atrium and clerestory from the pool deck area post construction.

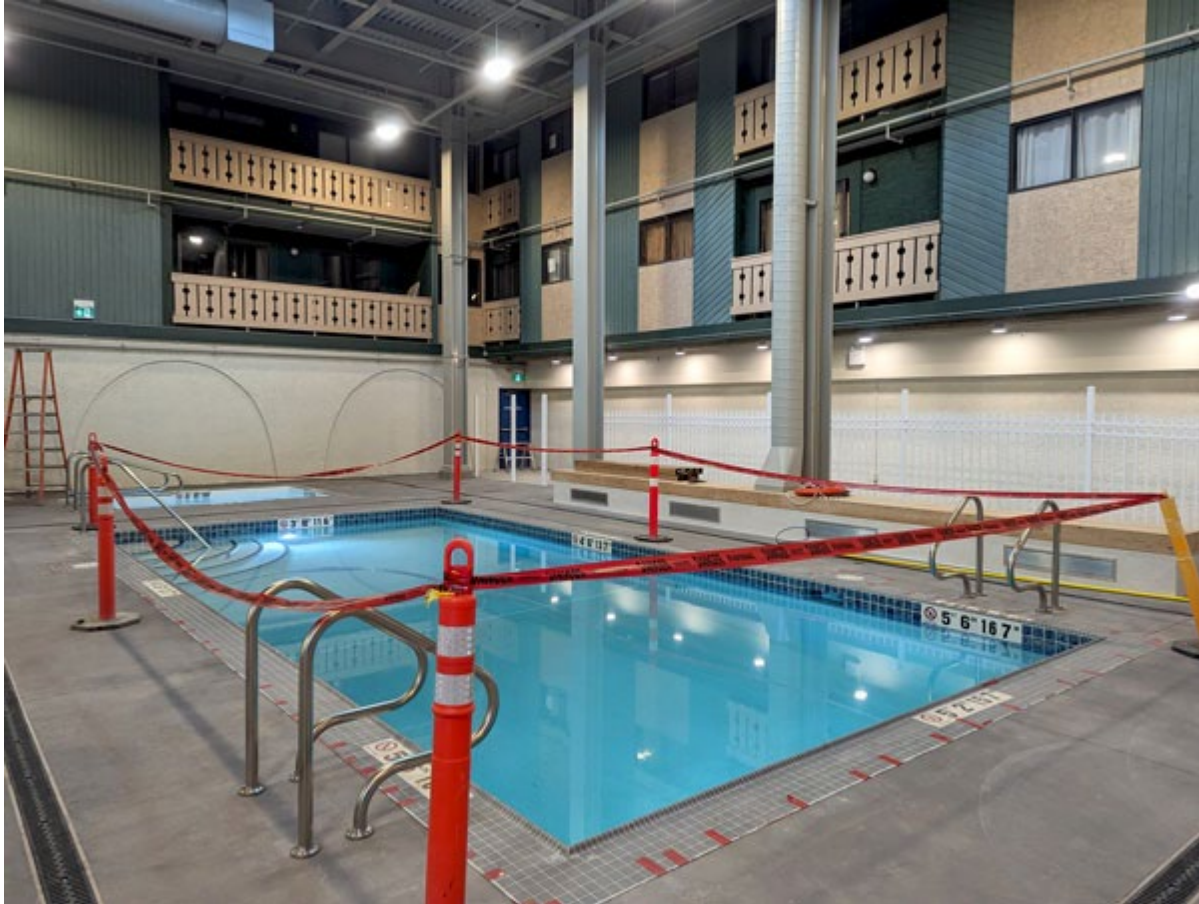
RJC ENGINEERS — Finished view of the pool and hot tub area within the atrium.

The design rationale for the open moment frames was to replicate what was there before with no cross-bracing within the atrium space which would block the views and sight lines of suite balconies which overlook a swimming pool in the atrium.

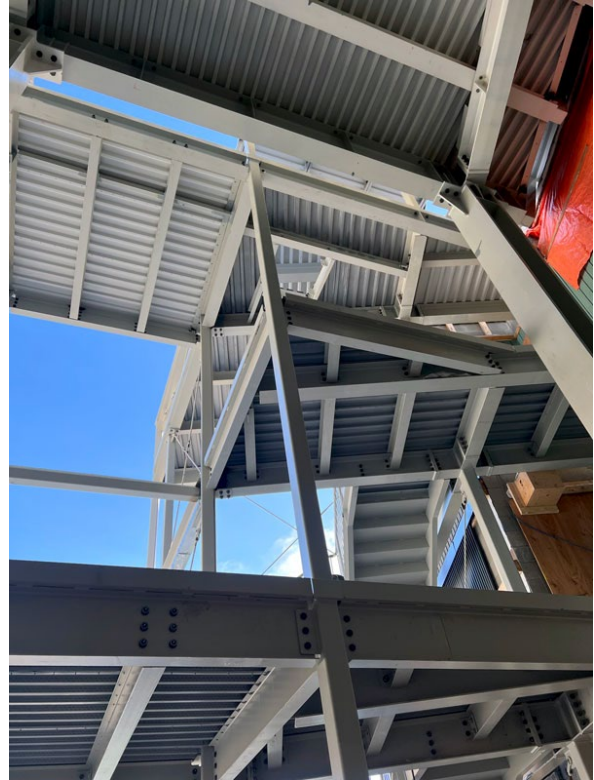
RJC ENGINEERS — View of the structural steel framing that makes up the new atrium entryway and stairs.

In November, the steel framing for a new front door entry, including the floor and roof deck, was also installed.
