# The Bishop's House in Kingston is being refreshed from top to bottom

Dan O'Reilly September 2, 2022

**O**ne of the most historic buildings in Kingston, Ont. is undergoing a top-to-bottom \$950,000 restoration.

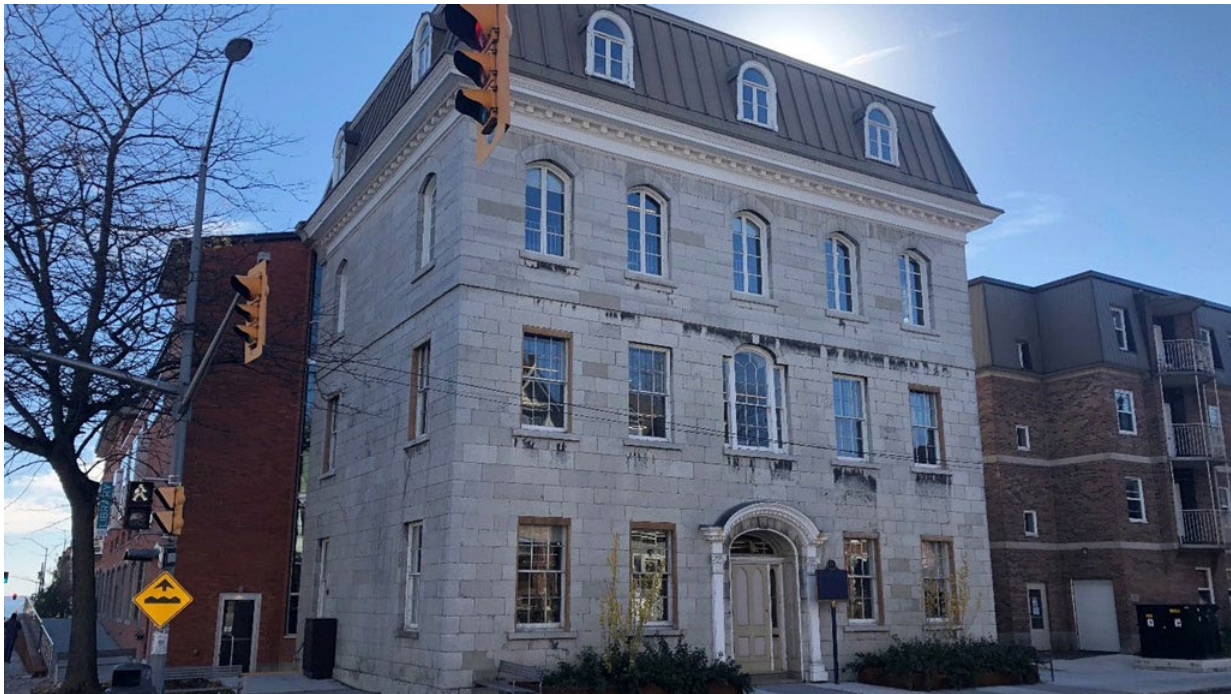
PHOTO COURTESY RJC ENGINEERS - Pictured is 130 Johnson St. in Kingston, Ont., also known as The Bishop's House. It is currently undergoing a \$950,000 restoration. This photo is prior to building envelope restoration.

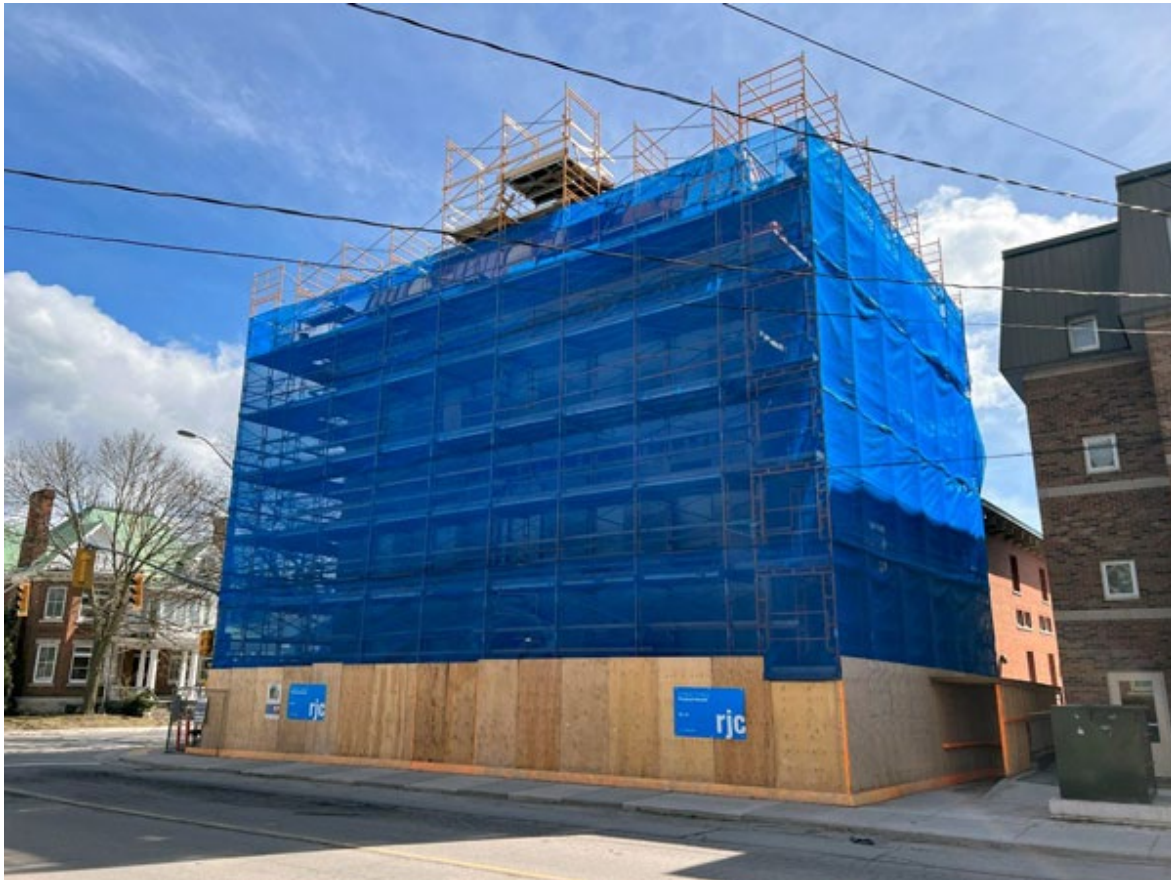
PHOTO COURTESY RJC ENGINEERS – The Bishop’s House under construction in early spring with full height scaffolding to allow access to all areas of each elevation.

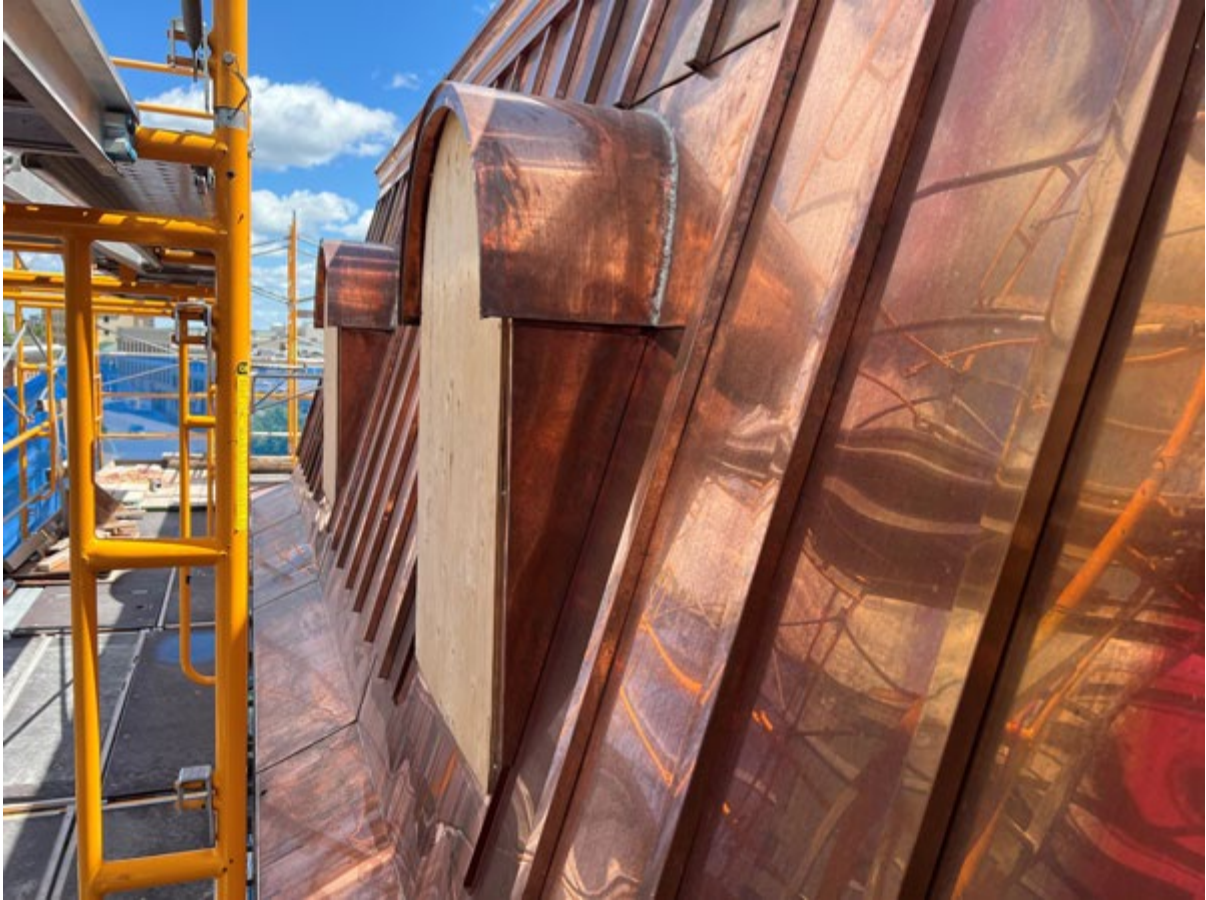
PHOTO COURTESY RJC ENGINEERS – As part of restoration a new copper mansard roof was installed.

The corroded decades-old metal mansard roof also had to be replaced and that also was a source of negotiations with city officials on what it should be replaced with. Eventually, it was decided it should be a copper one.

While this was not an original material, there are a number of buildings in the immediate area with copper roofs, including Kingston's historic city hall and St. George's Cathedral.

"So copper was deemed an historic supporting material within the sightlines of those buildings."

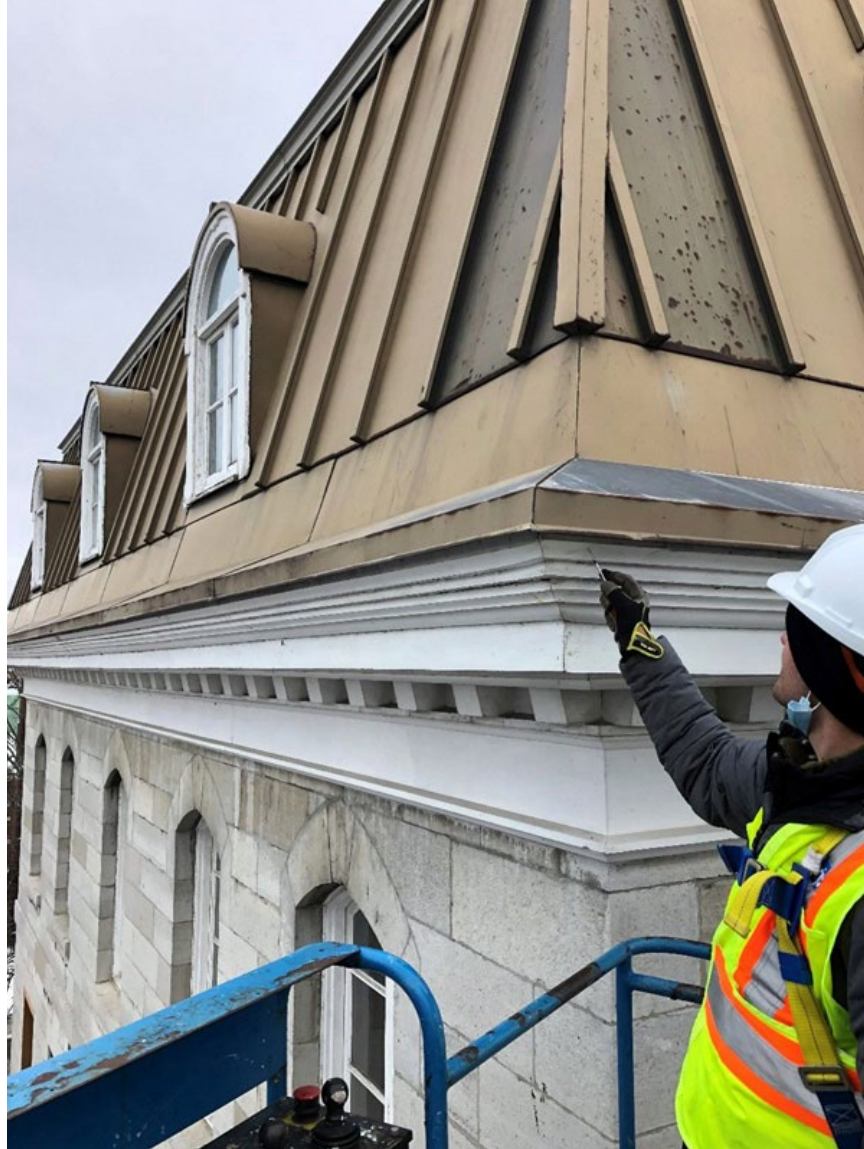
PHOTO COURTESY RJC ENGINEERS – Pictured is RJC Engineers completing a detailed condition assessment of the building envelope and masonry structure.

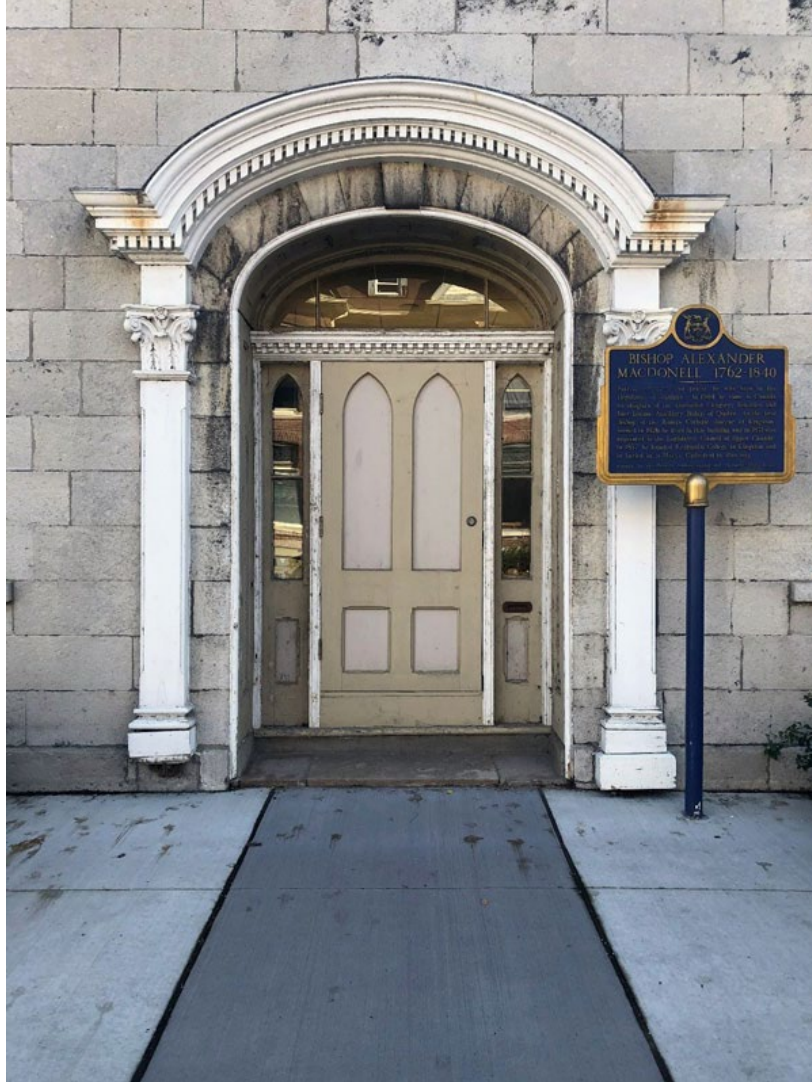
PHOTO COURTESY RJC ENGINEERS – The project includes the restoration of all wood elements throughout the building façade, including all windows, cornice, entrance door and roof canopy.

As for the restoration of the windows, that was a two-stage process.

Defective frames of the 27 windows on the ground, second and third floor windows were repaired onsite, while the sashes were restored off site in a local carpenter's shop. Most of the original single glass panes were reinserted, although a few badly cracked ones had to be replaced. While that was occurring the openings had to be boarded up with plywood, says Park.
